In the 1950s, BFGoodrich\* invented chlorinated polyvinyl chloride (CPVC) technology, a product of which plastic piping is made. One application of such piping is in fire sprinkler systems.

## Evidence that CPVC systems perform under fire

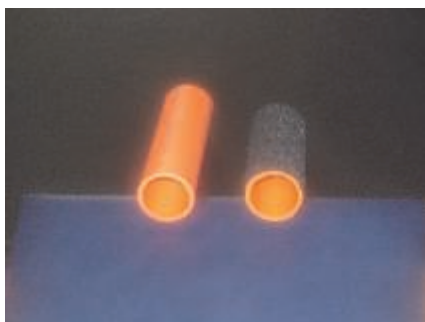
BlazeMaster® pipe and fitting compounds are made from chlorinated polyvinyl chloride, which is formed by reacting additional chlorine upon the polyvinyl chloride (PVC) polymer. While PVC contains approximately 57% total chlorine by mass, CPVC has approximately 67%. This additional chlorine content imparts unique performance attributes such as the ability to withstand a direct flame for long periods of time without sustaining combustion or continuing to burn. Instead, the CPVC pipe will char only on the outside wall when exposed to direct flame, while the pipe interior remains smooth.

A charring layer forms on the outside of the pipe when it comes in direct contact with a flame; this layer functions as a thermal barrier and reduces the conduction of heat into the pipe. In addition, CPVC piping systems are approved and used as wet systems only. The moment a sprinkler head activates, the water flow will carry away the heat and thus cool the pipe from the inside, which further reduces the rate of burning.

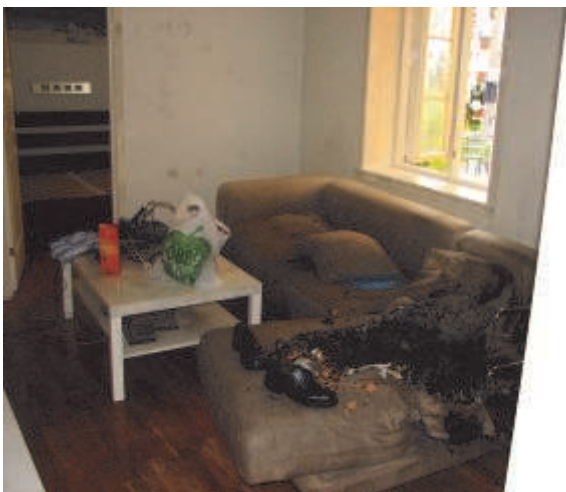
In May 2006, a fire broke out in a 1920s apartment building in Bergen, Norway. The fire was caused by a burning cigarette that had dropped from an ashtray and ignited a sofa. All 40 residents in the building were saved from injury or possible death thanks to a CPVC fire sprinkler system, which had been retrofitted as part of a major modernisation project in March, only three months before the fire.

The building has 35 apartments on six floors and had been retrofitted with 175 sprinklers. The chosen sprinkler system offered the residents a low-cost option that provided maximum fire protection with a minimum of disruption during installation. An additional advantage of the fire sprinkler system was that it made a secondary fire escape route unnecessary. This space saving served to increase the floor areas of some of the apartments, which subsequently increased their market value.

CPVC fire sprinkler systems have been in commercial use since 1984 and can contain and even extinguish a fire in less time than it may take for the fire brigade to attend the incident. If a fire is tackled effectively within the first four minutes it can make the difference between life and death. In the case of this apartment building, the timely retrofit demonstrated both the lifesaving function of the CPVC system as well as its role of protecting property.

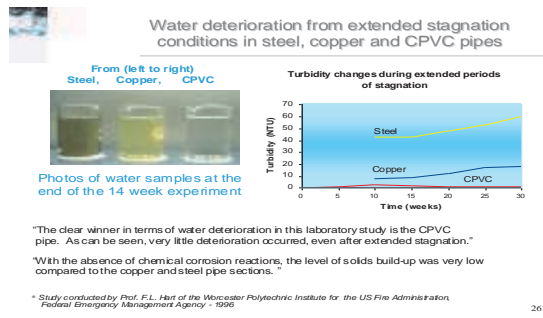
Tested and listed CPVC pipes and fittings should be WRAS (Water Regulations Advisory Scheme) approved for use with potable water, which is important if the sprinkler system is connected to the main water source.

CPVC systems also offer advantages after installation, in particular with regards to the impact of corrosion on long-term service life and water quality.

The quality of the water contained in a fire sprinkler system can have a corrosive effect on the piping material. Metal piping systems are subject to corrosion. Not only can that reduce the service life of the fire sprinkler system, but it can also cause the standing water in the pipework to deteriorate. In the event of a fire a sprinkler head activates and sprays water onto the flame, and while water damage will be restricted to a limited area (only the sprinkler head closest to the fire will activate), the quality of the water can play a part in the resulting damage.

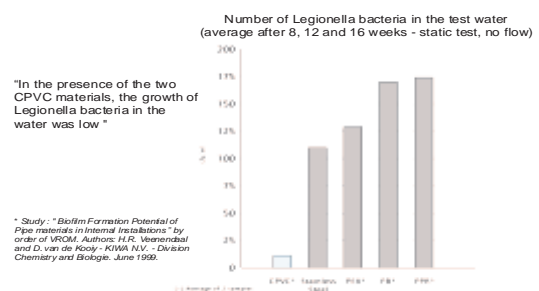
In 1999, the KIWA Institute in the Netherlands conducted a study following the request of the Dutch Ministry of Housing, Urban Planning and Environment. KIWA was to determine the biofilm formation potential of different kinds of pipe materials used in plumbing systems. The formation of biofilm within a piping system can contribute to growth of bacteria, such as Legionella pneumophila. The bacteria grows in (preferably) warm water in all kinds of piping systems and is more likely to develop in large buildings with complex water systems, such as hotels, hospitals and care homes.

The study (ref.2) has shown that the growth of Legionella is comparably low in CPVC plastic piping materials.
